Muon Design Note #08

DATE: February 24, 1986

TITLE: Chicago Cyclotron Magnet (CCM) 1985 Run Summary

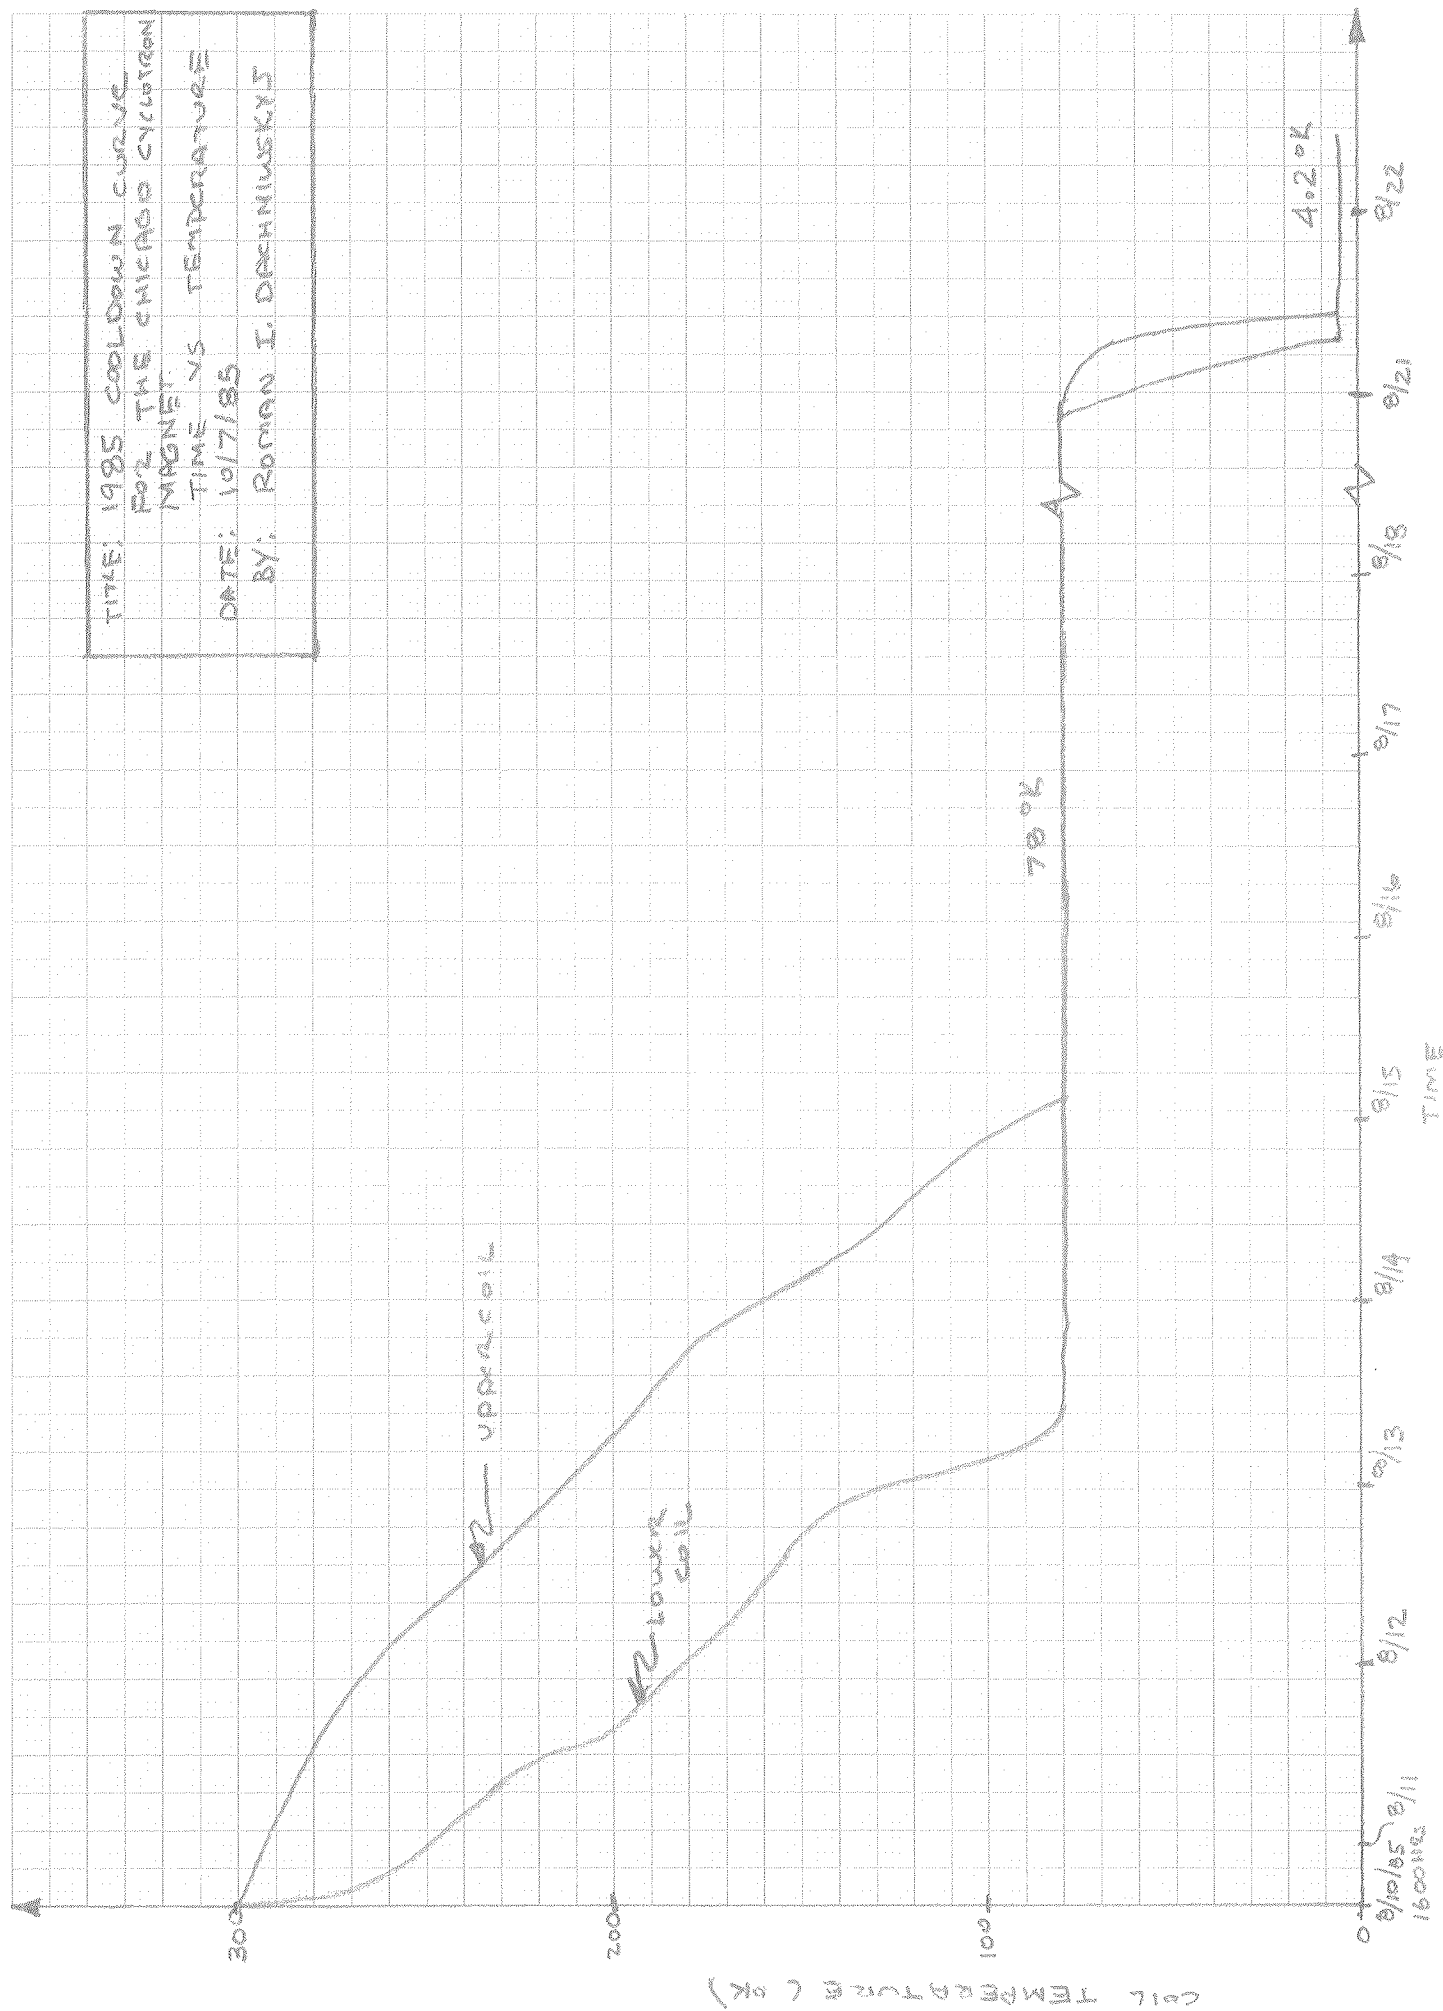
FIG1. COOLDOWN RATE FOR 1985 CHICAGO CYCLOTRON RUN

The CCM cooldown began on 8/10/85. Shortly after beginning the nitrogen precooling it was noticed mistakenly that the temperature of the coils was near 32°F. The precooling was stopped, because it was feared that somehow water had been frozen out on the coils. The problem was rectified when it was determined that the current going through the coils was not 100 milliamps but some lower value because of a 600 ohm shunt that was placed in parallel across the coils. The coil temperature is determined by dividing the voltage drop across an individual coil by the current to get the coil resistance and then this resistance is looked up in a graph to determine temperature. The precooling with nitrogen took 5 days and was completed on 8/15/85. The CCM coils were soaked at liquid nitrogen temperature for 4 days. The nitrogen precooling rate for the 1985 run, Fig. 1, was very similar to the cooldown rate from a previous run shown in Fig. 2.
